SUNSET LAKE DAM

DE 00046

PHASE 1 INSPECTION REPORT

NATIONAL DAM SAFETY PROGRAM

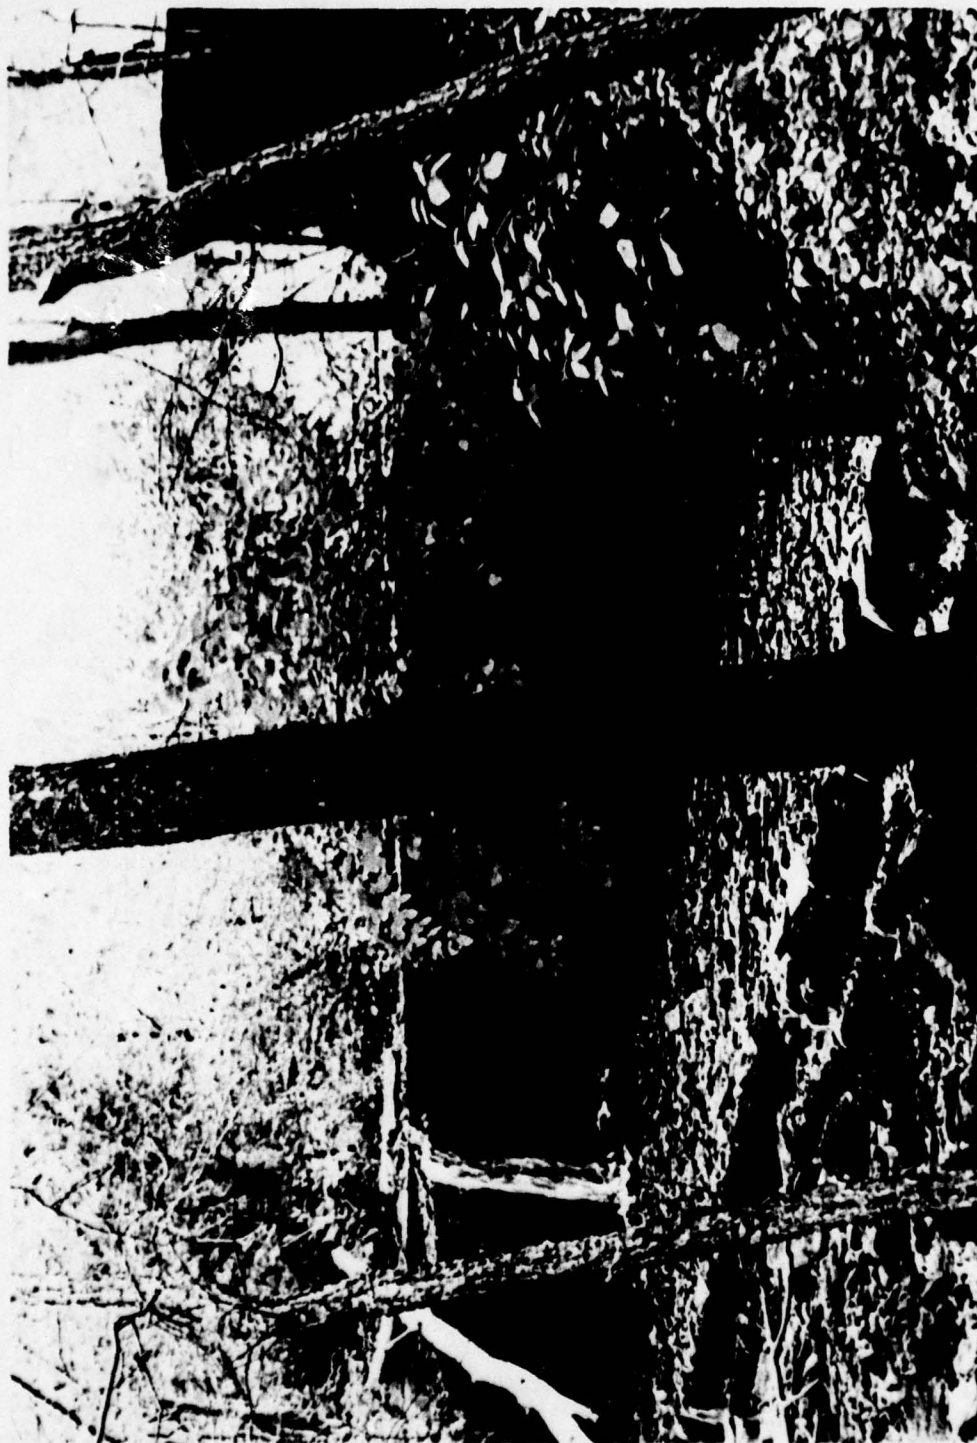
OVERALL VIEW
OF
CONCRETE OVERFLOW DAM

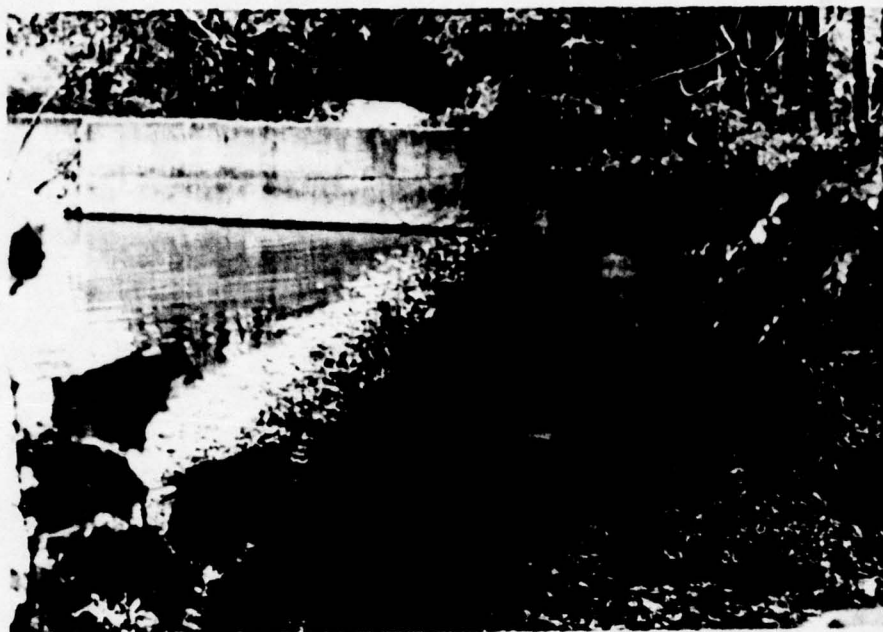
Surface cracks appear in the west wingwall at the concrete overflow structure, at the location where the wall had been raised in height by adding a layer of concrete. At the junction between the layers, a crack had formed.

- PHOTO 3 - View looking toward west wing wall. A horizontal surface crack is notable where the wall height may have been increased.
- PHOTO 4 - View of spalled concrete at downstream end of west wing wall. Horizontal crack notable where two separate pours (layers) of concrete have not been joined correctly. Crack not apparent on stream face of wall.
